# Commercial Baseline Study: Where are we?

Nigel Makela

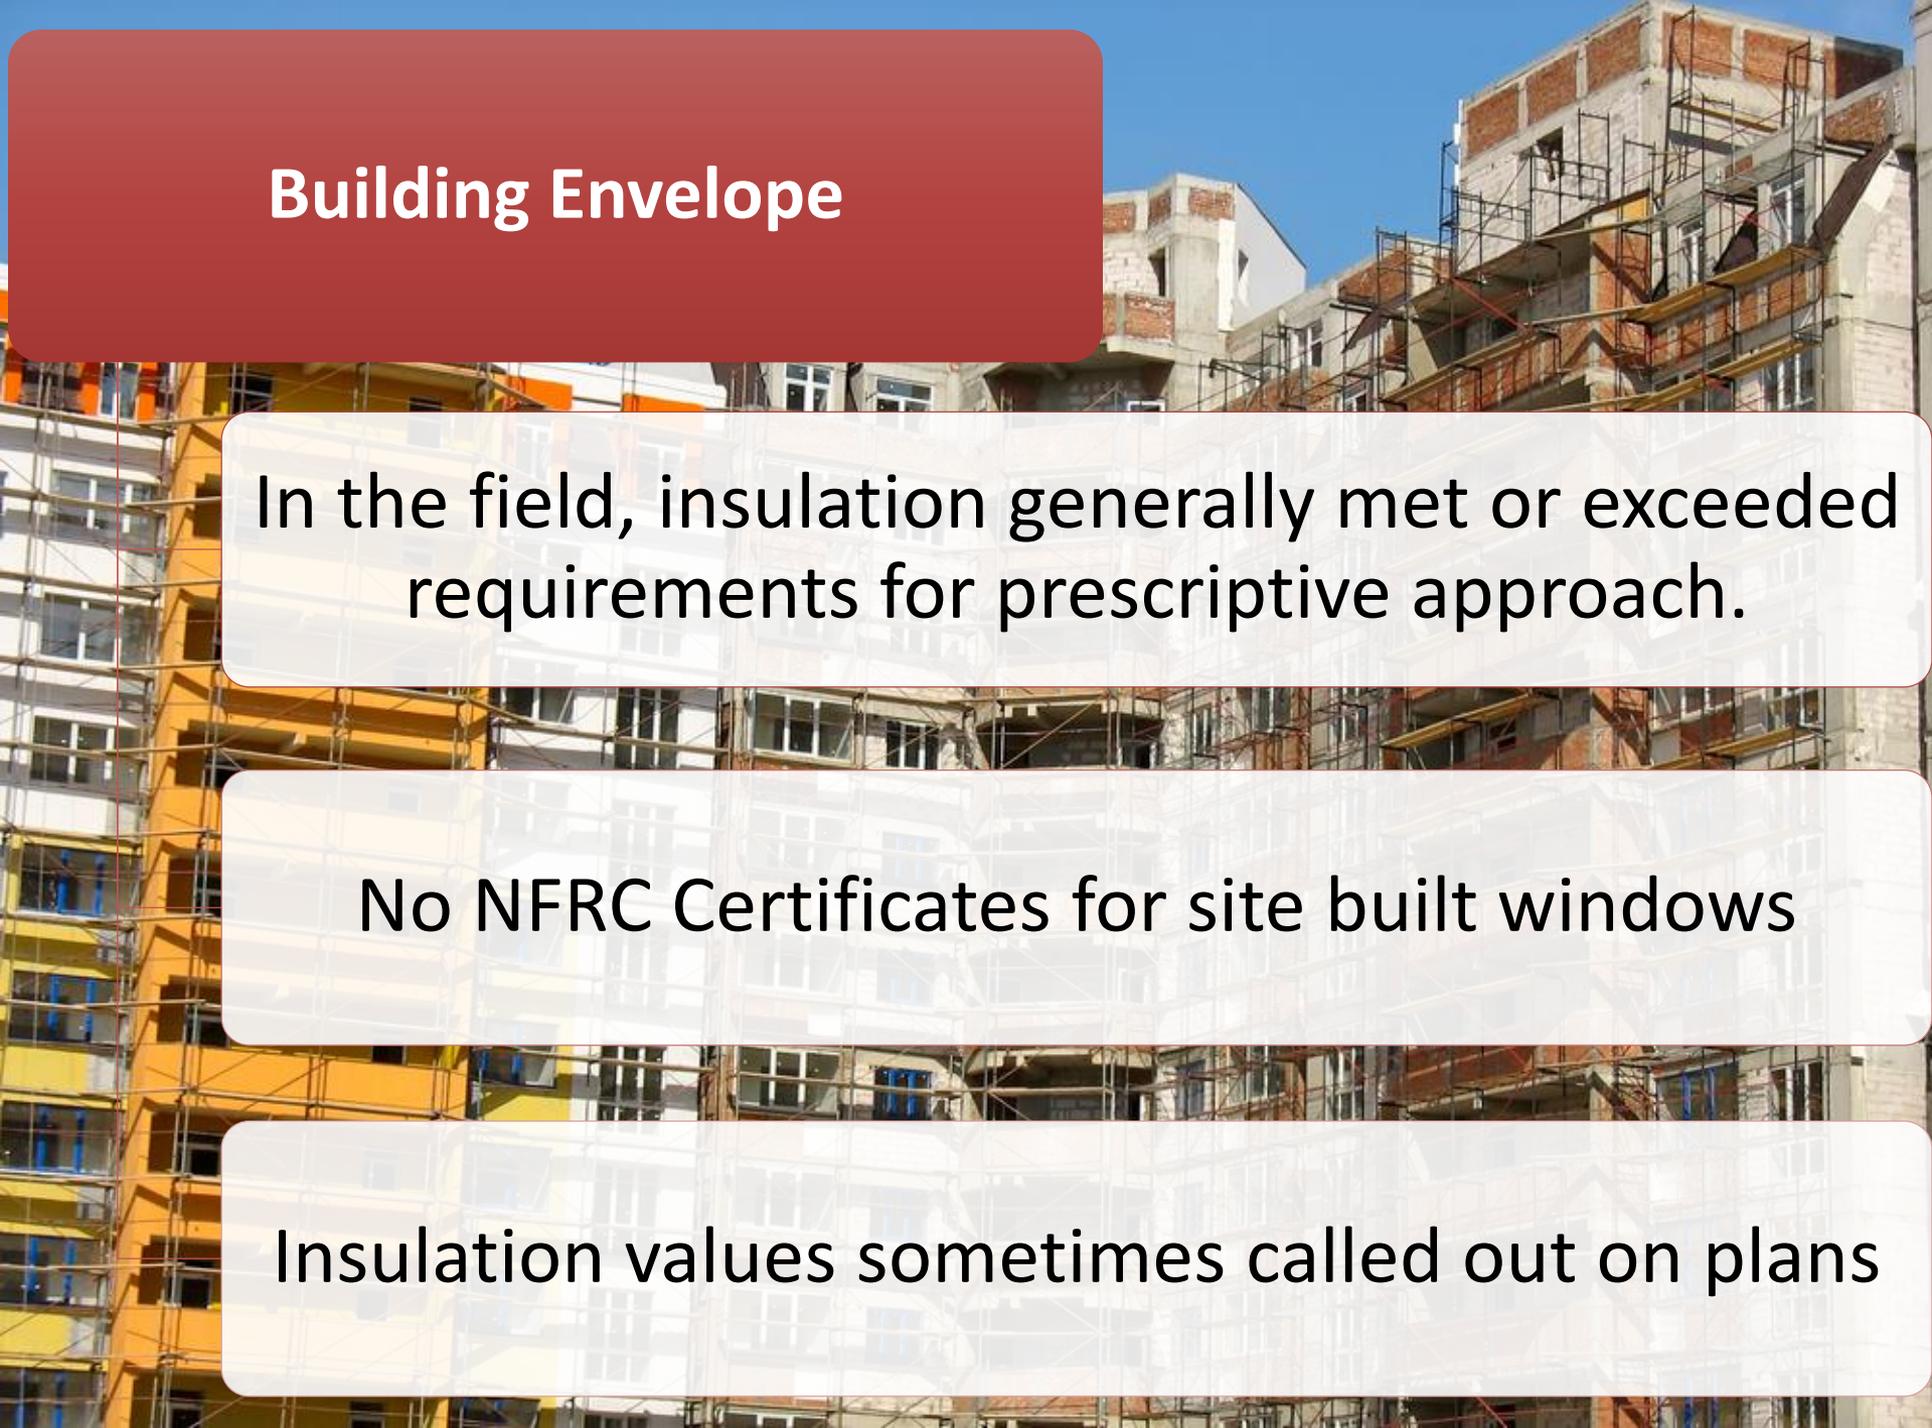
## Building Envelope

In the field, insulation generally met or exceeded requirements for prescriptive approach.

No NFRC Certificates for site built windows

Insulation values sometimes called out on plans

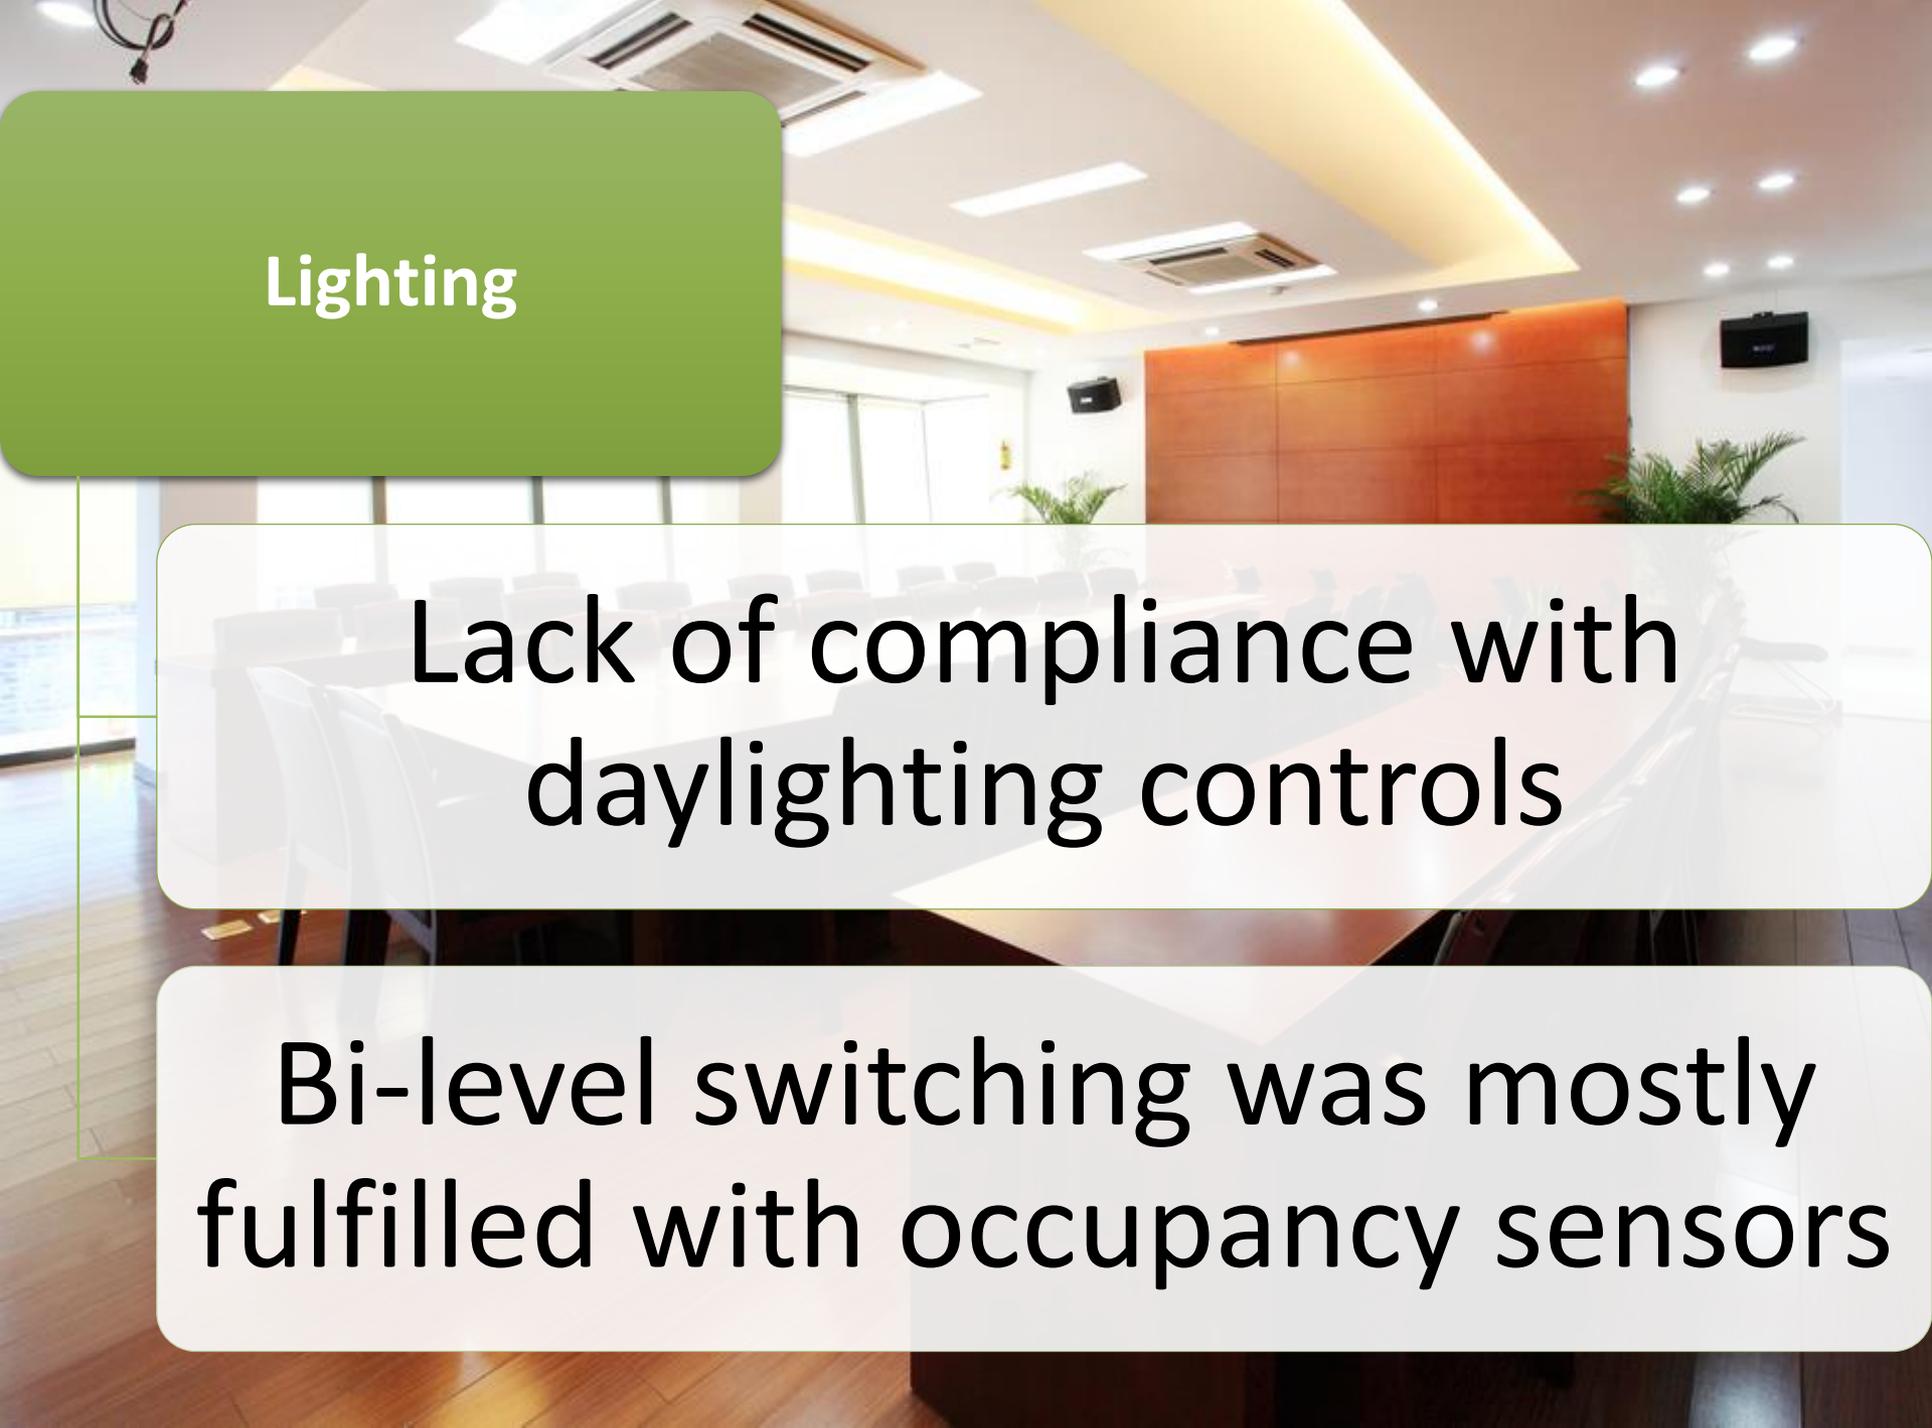
## Lighting

Lack of compliance with daylighting controls

Bi-level switching was mostly fulfilled with occupancy sensors

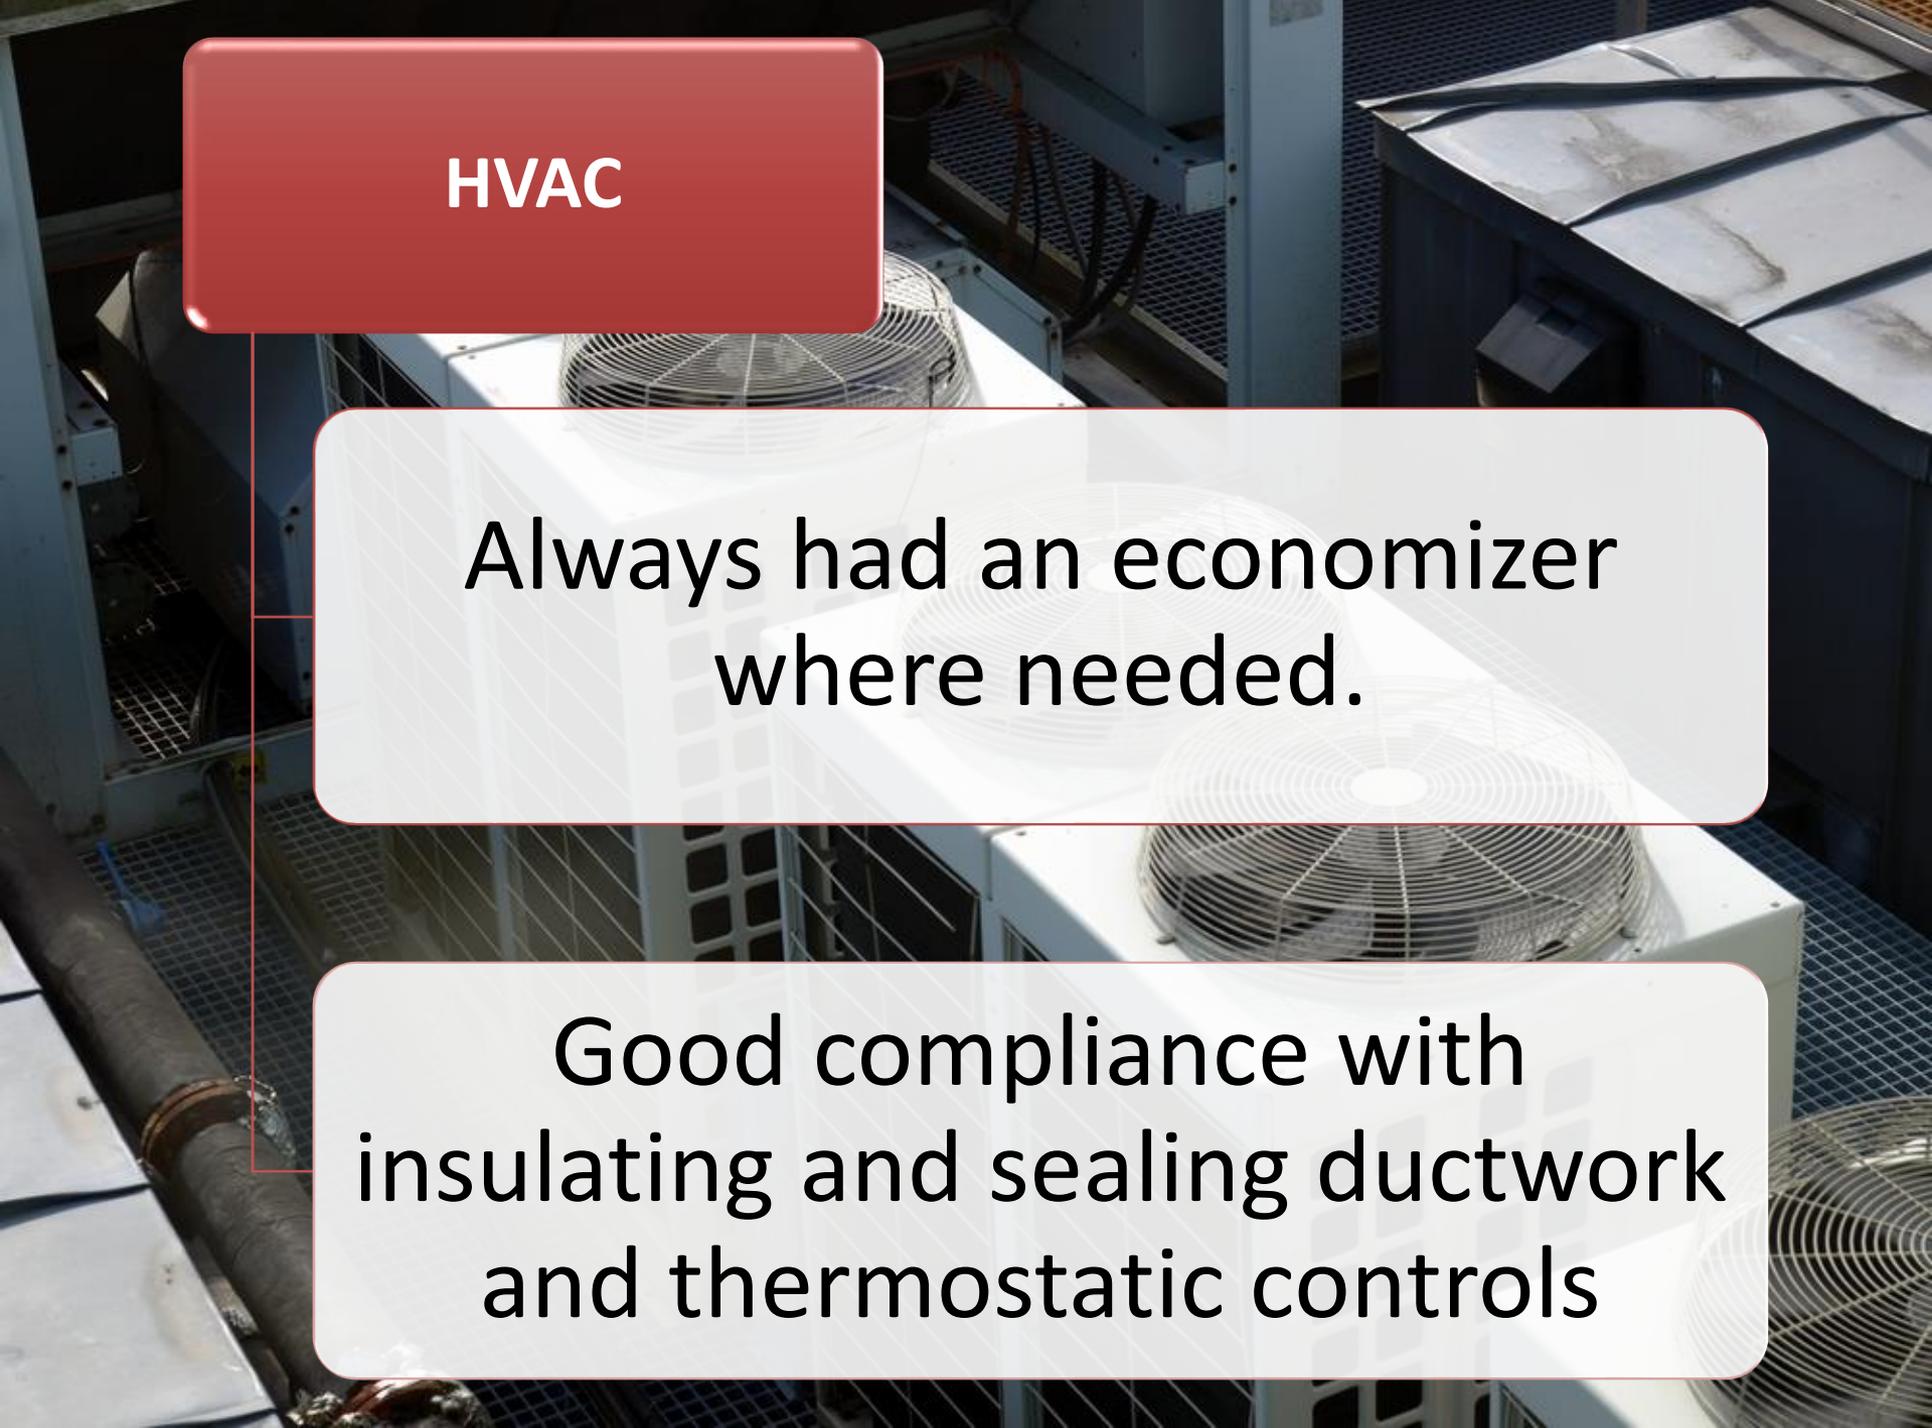
## HVAC

Always had an economizer where needed.

Good compliance with insulating and sealing ductwork and thermostatic controls
